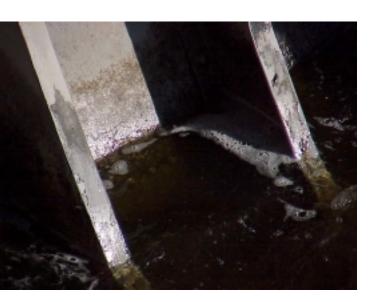
2001 - Epoxy E-303, MIL-P-24441 F150 & F151, Devcon. Most of the Devcon is gone in 9 years due to poor intercoat adhesion to the epoxy.

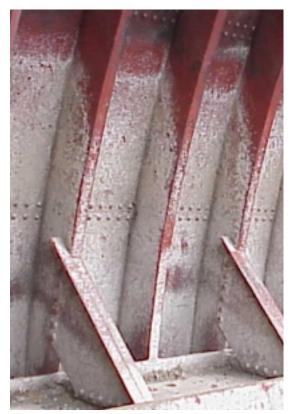
2000 - Epoxy E-303, MIL-P-24441 F150 & F151,Devcon Coat after 8 years service.
